MINISTRY OF ROADS AND TRANSPORT  
STATE DEPARTMENT FOR TRANSPORT  
**AIRCRAFT ACCIDENT INVESTIGATION DEPARTMENT**

INVESTIGATION REPORT /03/2024

**PRELIMINARY INVESTIGATION REPORT ON THE MIDAIR  
COLLISION ACCIDENT INVOLVING CESSNA C172M AIRCRAFT  
REGISTRATION 5Y-NNJ AND BOMBARDIER DE HAVILLAND  
DASH 8 DHC 8-315 AIRCRAFT REGISTRATION 5Y-SLK, ON 05  
MARCH 2024 AT THE NAIROBI NATIONAL PARK, NAIROBI  
COUNTY**

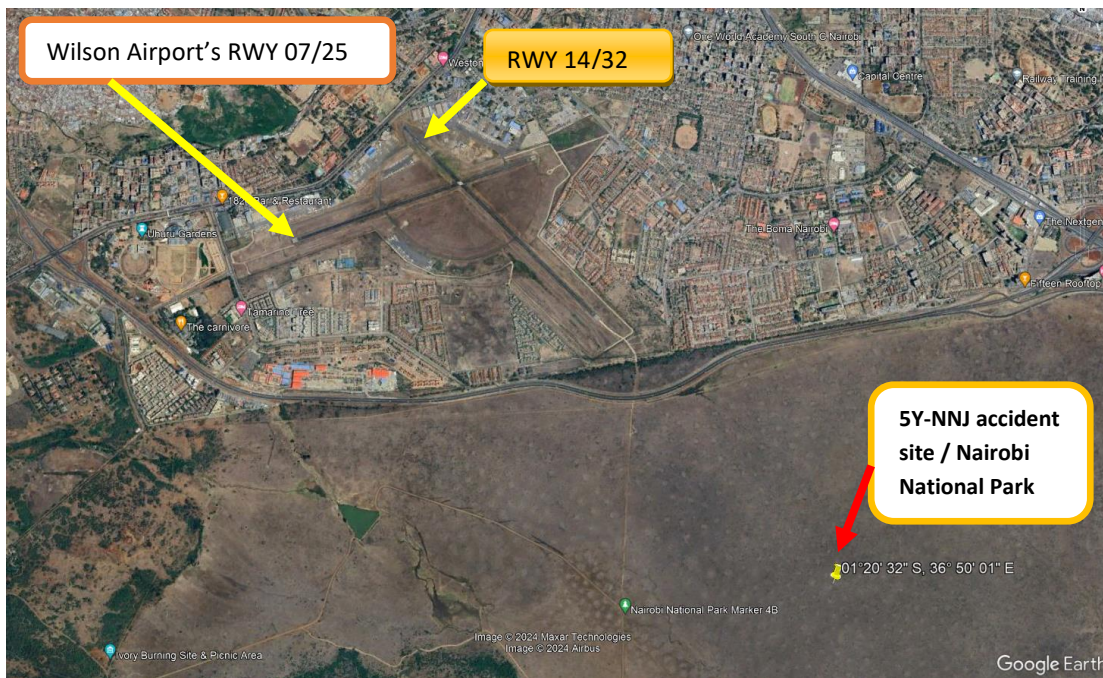
**FIGURE No. 1 – Aerial view of Wilson airport and 5Y-NNJ crash site (source: Google earth, with AAID annotations).**

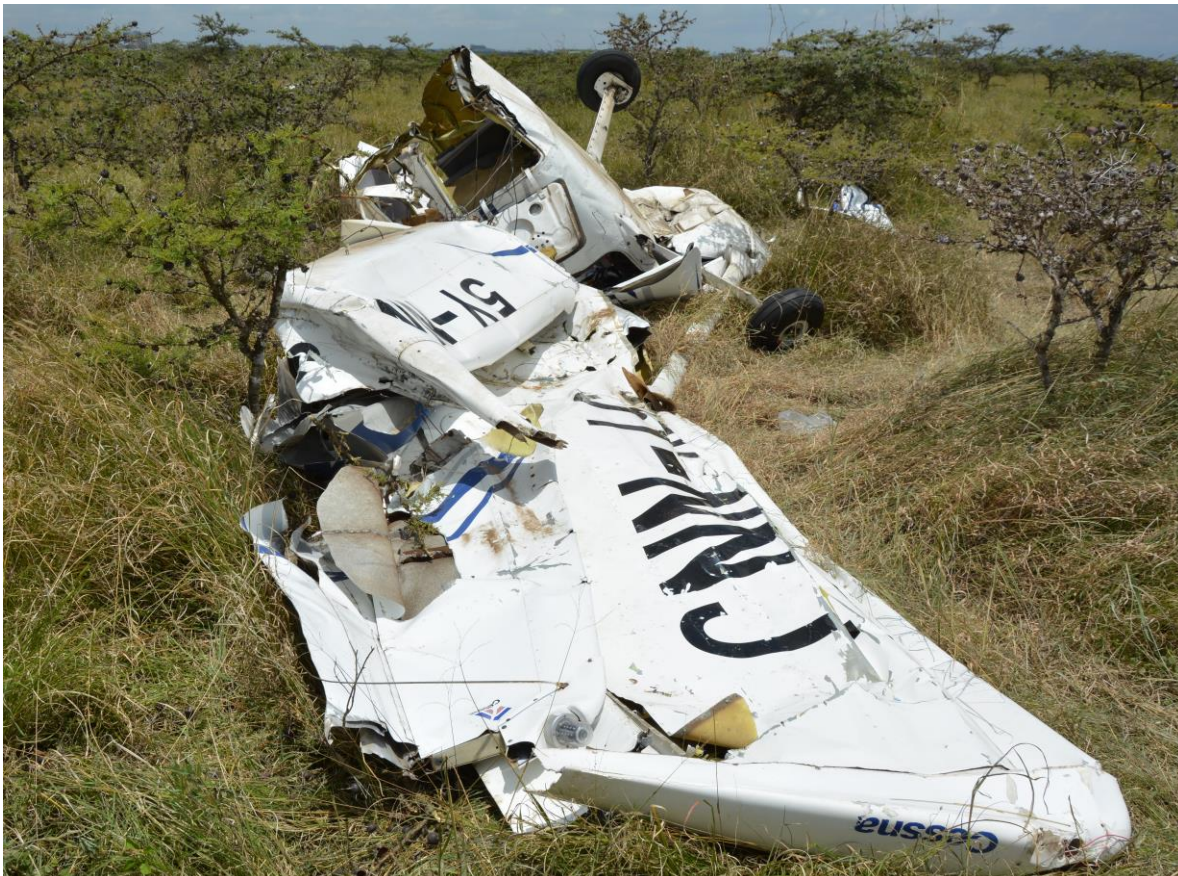
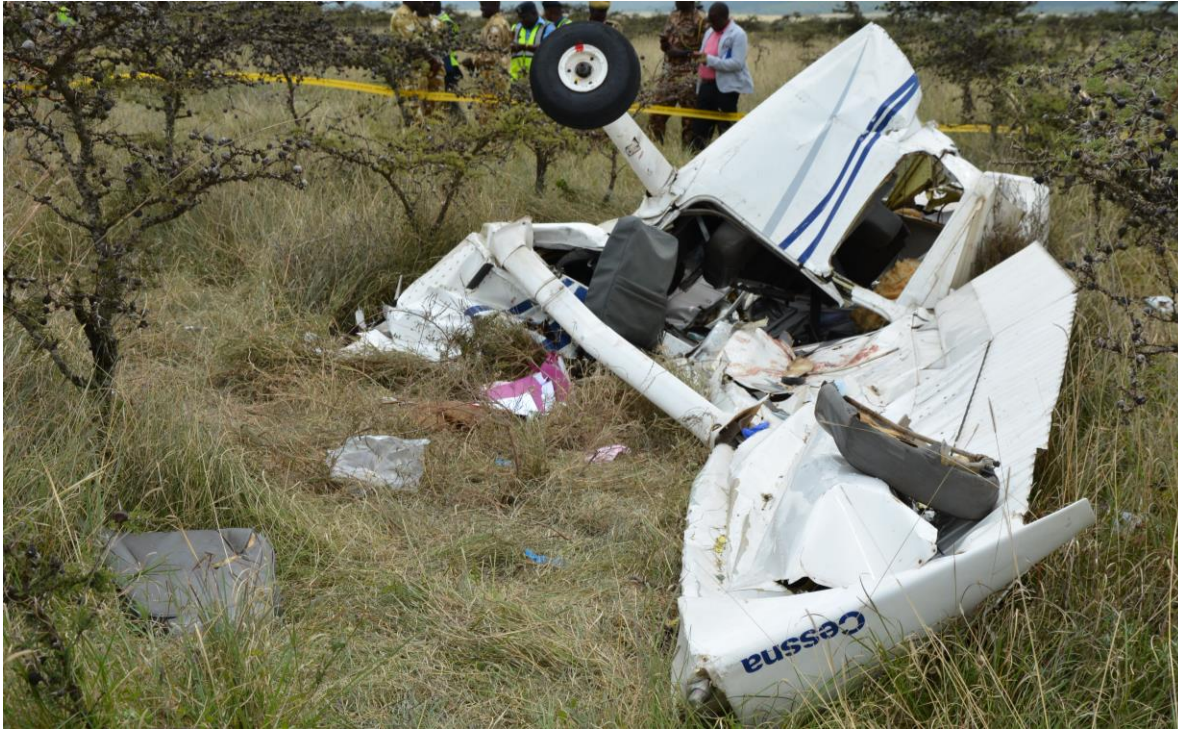
*FIGURE No. 2 and 3 – Photos of the accident site of 5Y-NNJ*

The aircraft was destroyed on coming into contact with the Bombardier De Havilland Dash 8 DHC 8-315 aircraft and on impact with terrain. The fuselage broke into several sections with the front section, wing, nose and main landing gear, and part of the empennage (vertical stabilizer and rudder) remaining localised in one area. The rest of the empennage (right and left horizontal stabilizer, elevator and trim tab) rested at various locations near the main wreckage.

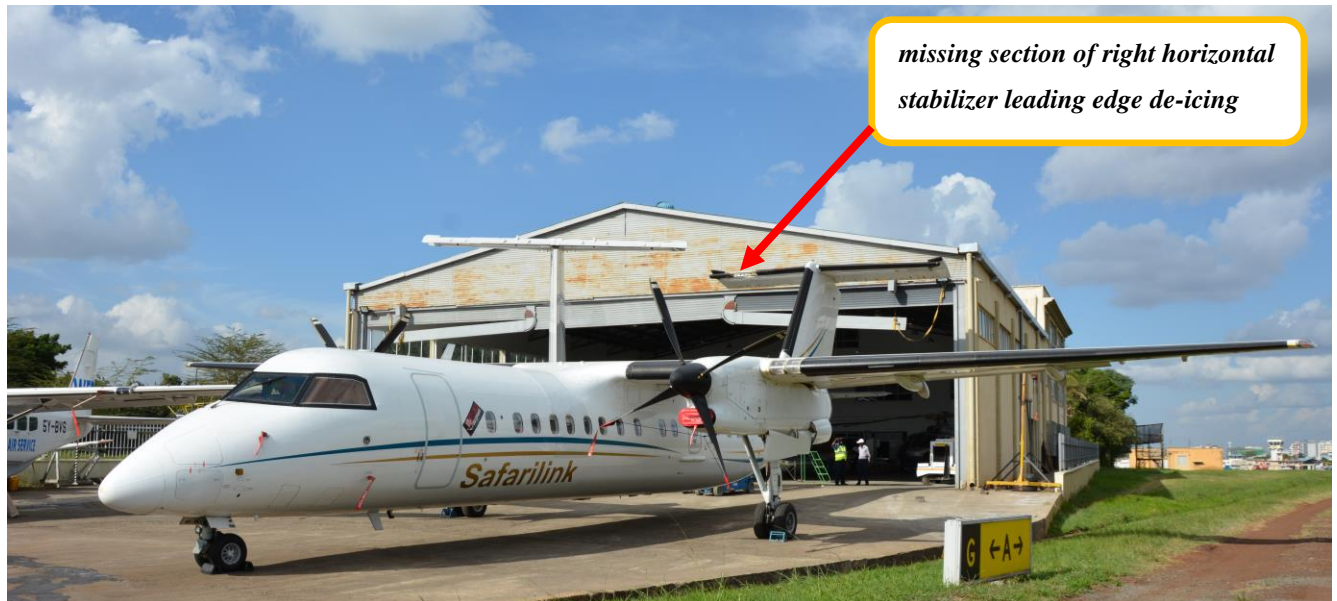
FIGURE No. 4 – A photo of 5Y-SLK parked outside the operator's hangar after the midair collision accident

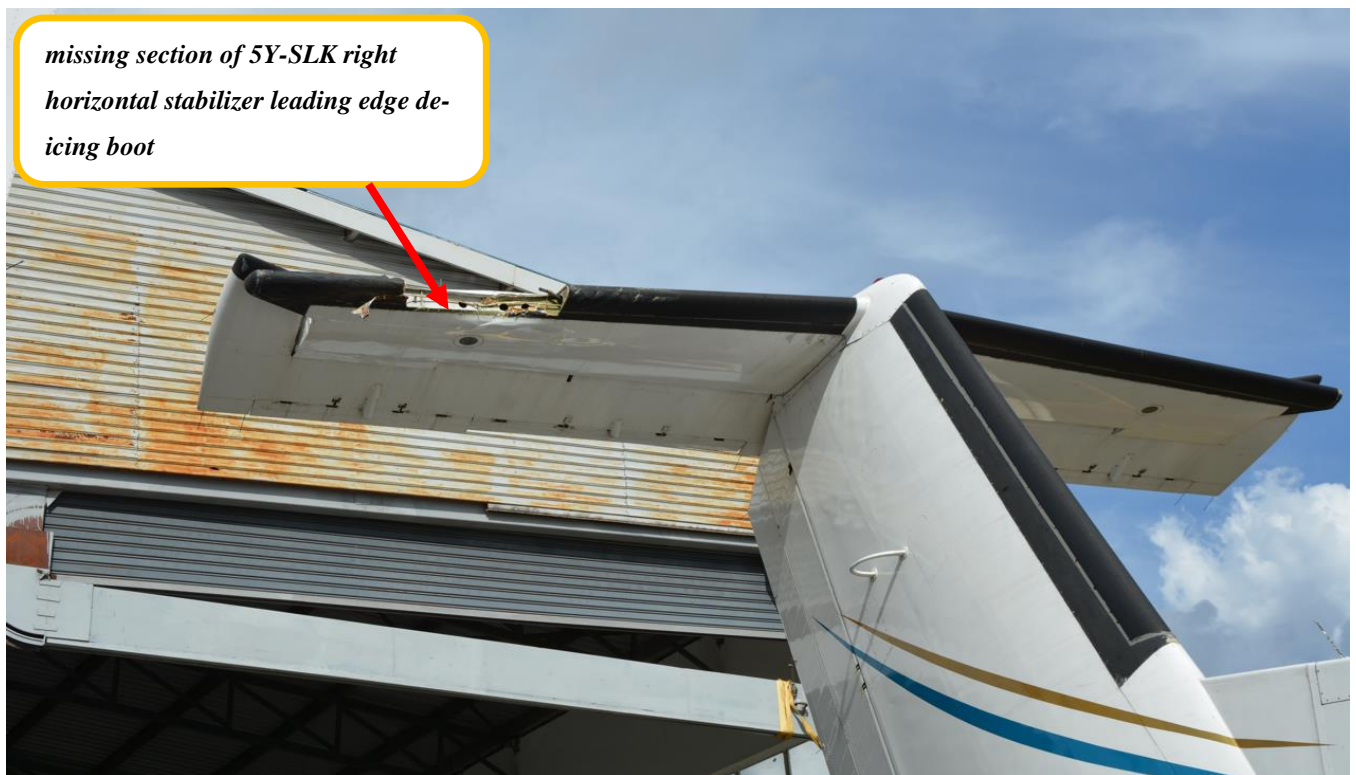
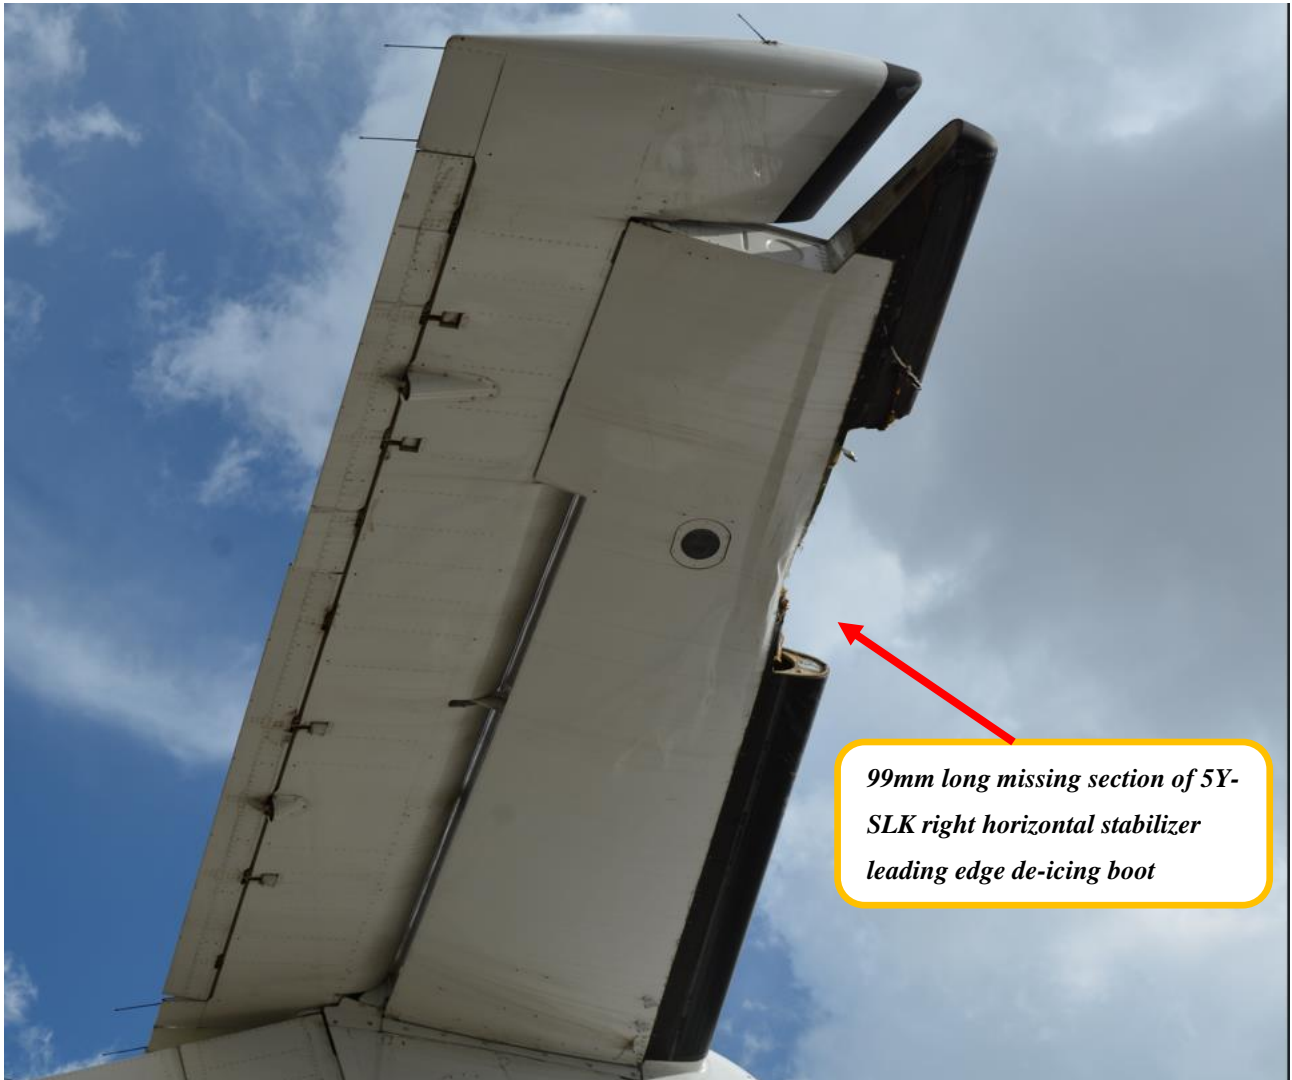
*FIGURES No. 5 and 6 – Photos of the missing section of right horizontal stabilizer leading edge de-icing boot*

The aircraft sustained minor damage to the right horizontal stabilizer de-icing boot. The missing right outboard horizontal stabilizer leading edge de-icing boot was found at the accident site near the main wreckage of 5Y-NNJ.

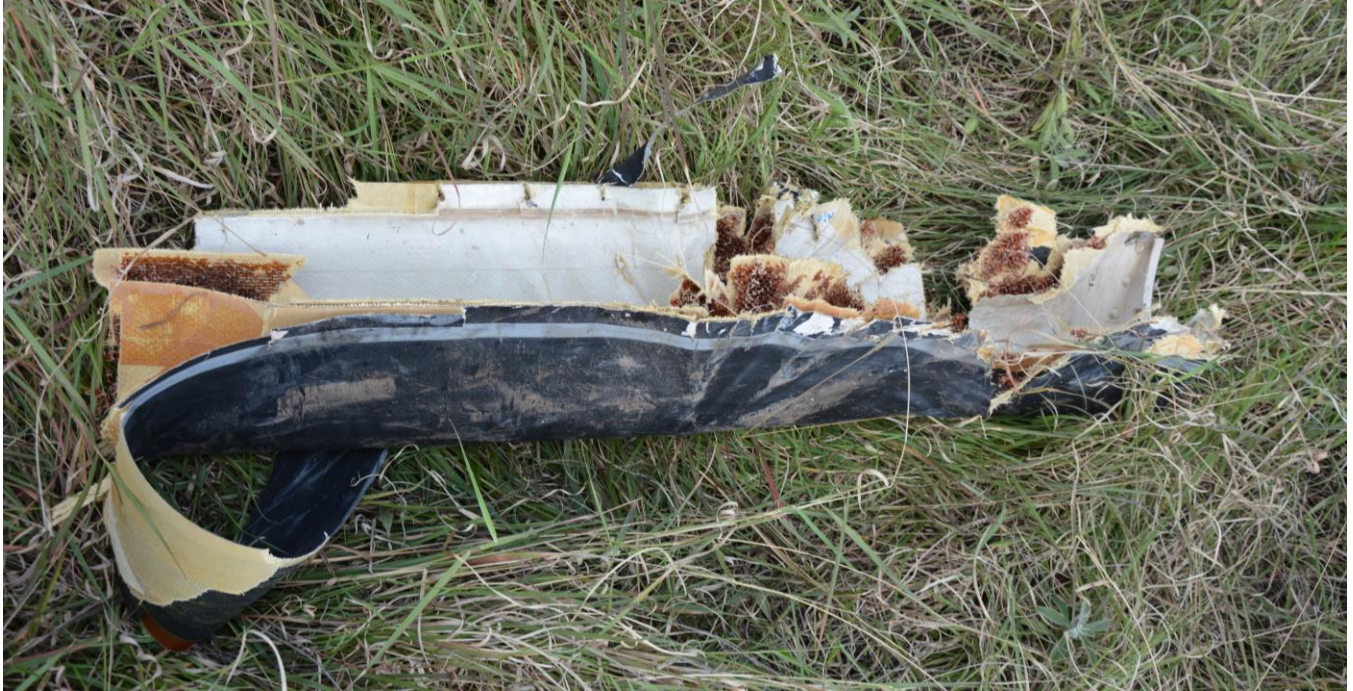
*FIGURE No. 7- A photo of the right outboard horizontal stabilizer leading edge de-icing boot at the 5Y-NNJ crash site*

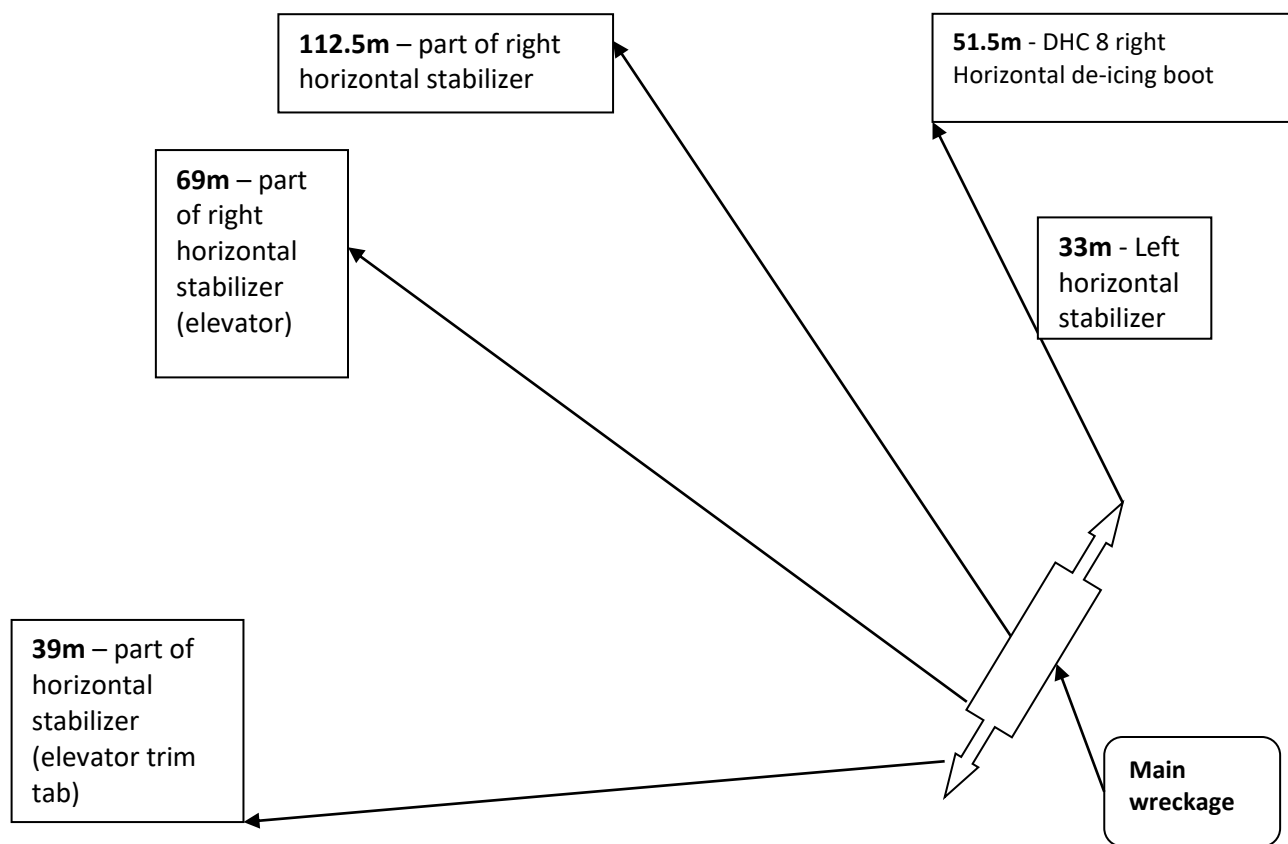
**FIGURE No. 12 – A general sketch of the 5Y-NNJ accident site wreckage distribution and distance from the main wreckage to other parts – not to scale**

The accident site of 5Y-NNJ was about 1.663 NM inside the Nairobi National Park to the right side of extended centreline of RWY 14 (upwind), coordinates 1° 20' 32" S, 36° 50' 01" E. The horizontal stabilizer of 5Y-NNJ broke midair into several pieces when the aircraft came into contact with 5Y-SLK's right horizontal stabilizer leading edge de-icing boot. The parts fell at a distance from the main wreckage. The initial midair collision point of 5Y-NNJ was the lower empennage (tail plane) severing the horizontal stabilizer that fell first at different locations along the flight path and in three pieces comprising part of the left horizontal stabilizer and the elevator, part of the left stabilizer, and part of the left elevator and elevator trim tab. 5Y-SLK 99mm width right horizontal stabilizer leading edge de-icing boot was found 18.5m away from the left horizontal stabilizer of 5Y-NNJ. The main wreckage was found to be the last along the flight path and it broke into several sections with the front section, wing, nose and main landing gear, and part of the empennage (vertical stabilizer and rudder) remaining localised in one area. The engine and propeller were covered under the nose wheel assembly. The cockpit and various indicators were destroyed. Fuel tanks ruptured and there was evidence of fuel saturation on the ground.

5Y-NNJ was found to have also been destroyed by deceleration forces as it impacted the levelled terrain in a high angle. Part of the tail plane separated from the main fuselage and curved upwards 40° at 130m aft of the baggage area (reference station 108.00).

Onsite investigation observed that the midair collision occurred when the tail section of 5Y-NNJ came into contact with the 5Y-SLK's right horizontal stabilizer leading edge de-icing boot. The aircraft, having spiralled to the ground, was found facing the opposite direction to the flight path.
